The effects of tropical cyclone Vance on Exmouth

by Greg Reardon (Cyclone Testing Station, James Cook University, Townsville), Geoff Boughton (Curtin University of Technology, Perth), David Henderson and John Ginger (Cyclone Testing Station, JCU)

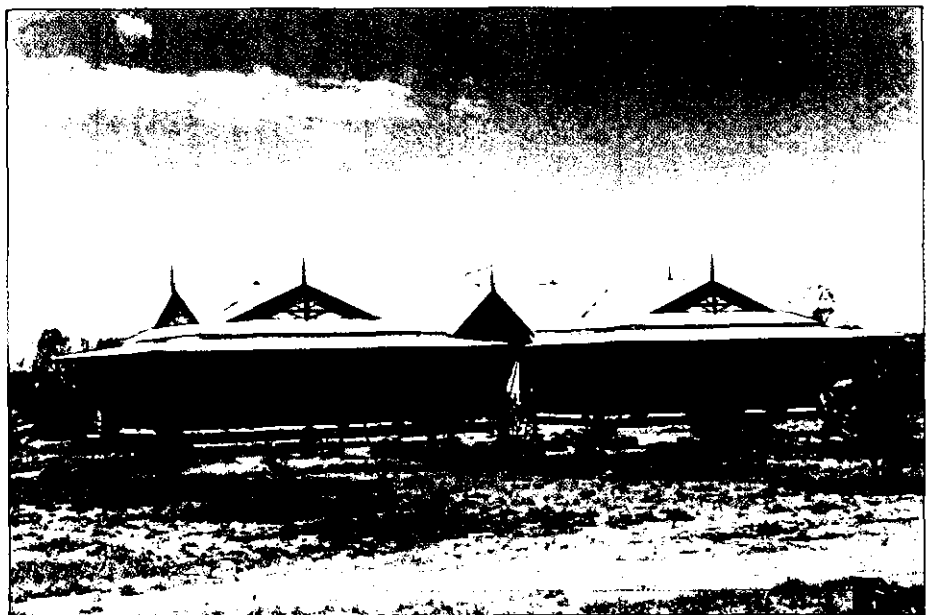
Photo 1: The majority of newer houses successfully resisted the wind forces.

The DHA houses also performed well, having virtually no major structural damage. The majority of the newer houses successfully resisted the wind forces (see *Photo 1*) although most had the advantage of being at the northern end of town where the wind speed is estimated to be slightly less.

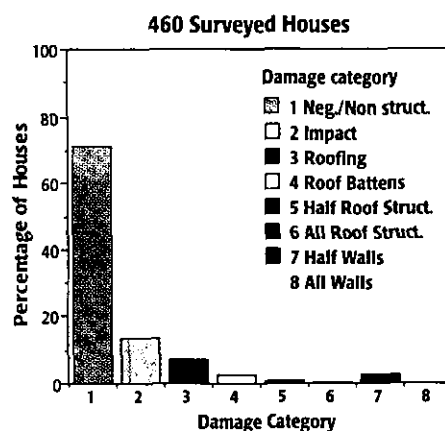
Figure 1 Distribution of damage—all houses

Figure 1 shows a graph of the distribution of damage for all houses surveyed.

Figure 1 shows that about 70% of housing had only minor damage and a further 15% was damaged by debris. Thus only about 15% of houses had structural damage, including loss of roofing. These statistics were unexpected for a town that had been hit by winds of up to 250 km/h. After cyclone Tracy, a category 4 event, Darwin had much higher percentages of serious damage (Lester and Reardon, 1976). Even the damage potential listed in Table 1 for category 4 wind speeds predicts greater damage than shown in Figure 1.

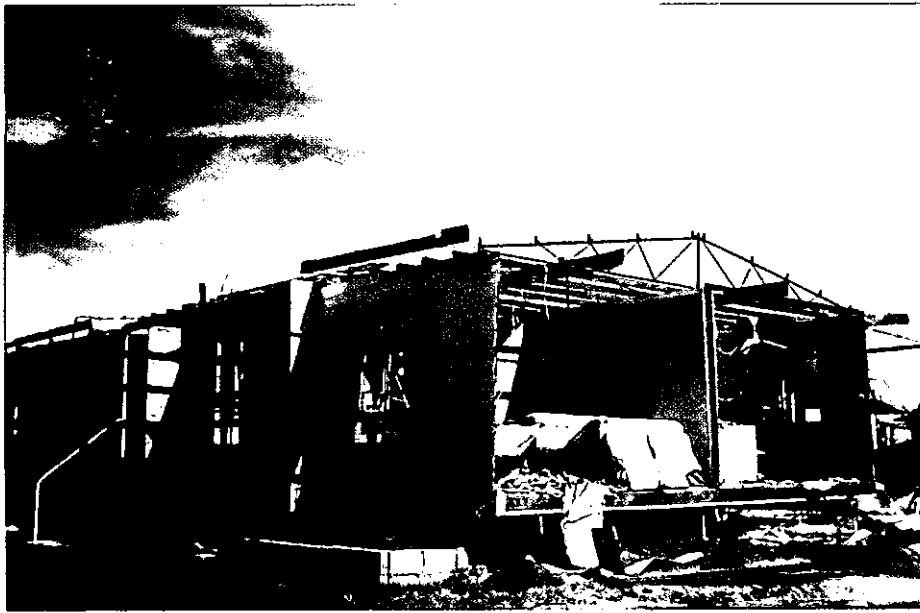
Photo 2: Transportable houses put in the poorest performance of any housing group.

The transportable houses put in the poorest performance of any of the groups. This type had generally been built in two sections in Perth, transported to the site and joined together. They lost roof structure and sometimes walls. Most of them were of older construction, with timber framed walls and timber or steel roof trusses. *Photo 2* shows one that had lost its roof and walls. At least one new steel framed transportable house on the southern outskirts of town lost its entire roof structure (*Photo 3*) due to inadequate fixing of the trusses.

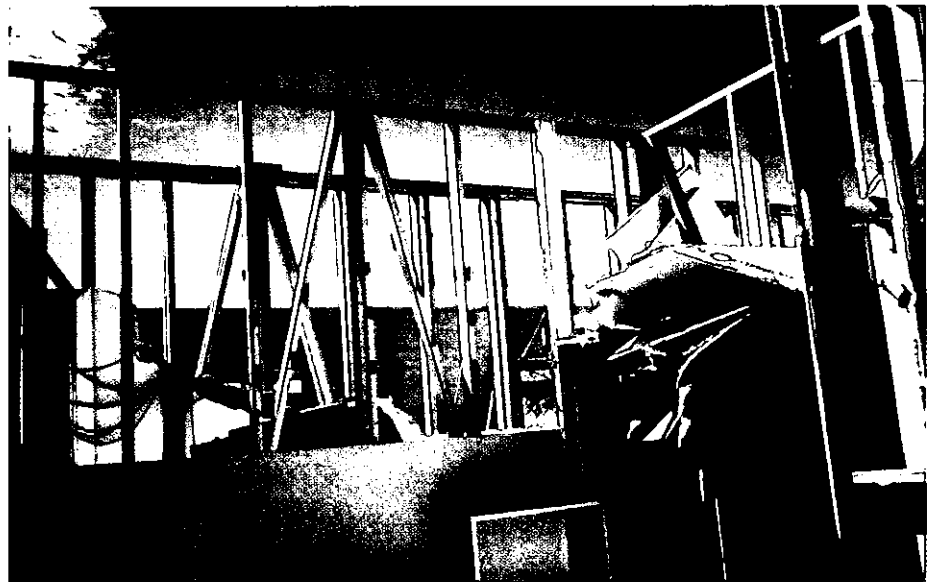
Photo 3: This new transportable home lost its entire roof structure due to inadequate fixing of trusses.

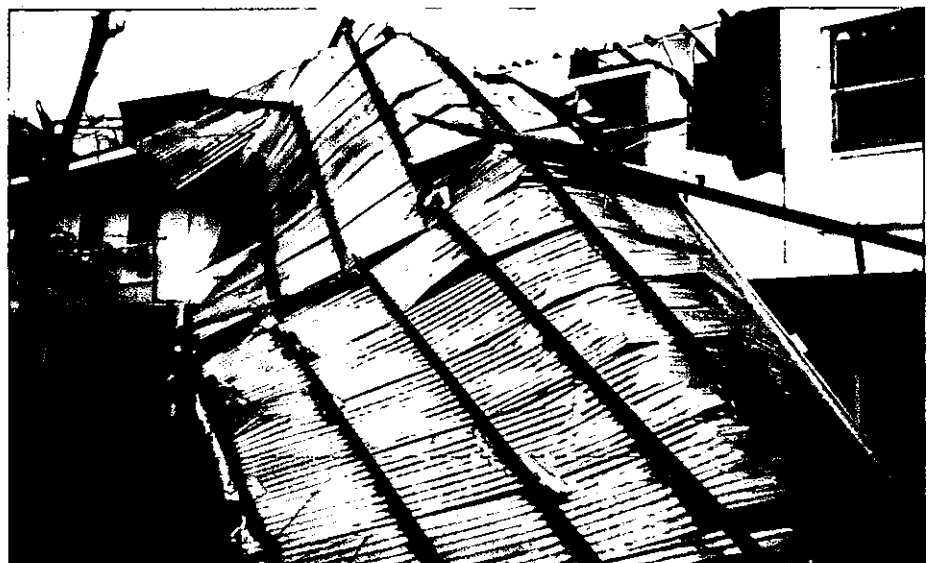
Four out of five blocks of flats lost their entire roof structure from the leeward slope in similar fashion. *Photo 4* shows one of the roof slopes. In each case the leeward slope

peeled off in one piece, initiated by failure near the ridge. Failure was a classic case of inadequate tie down from roof to foundations. The plane of the roof structure had been well designed with robust members bolted together and an adequate bracing system. But the tie down to internal party walls was not sufficient.

Photo 4: On this block of flats, the leeward roof slope peeled off in one piece, initiated by failure near the ridge.

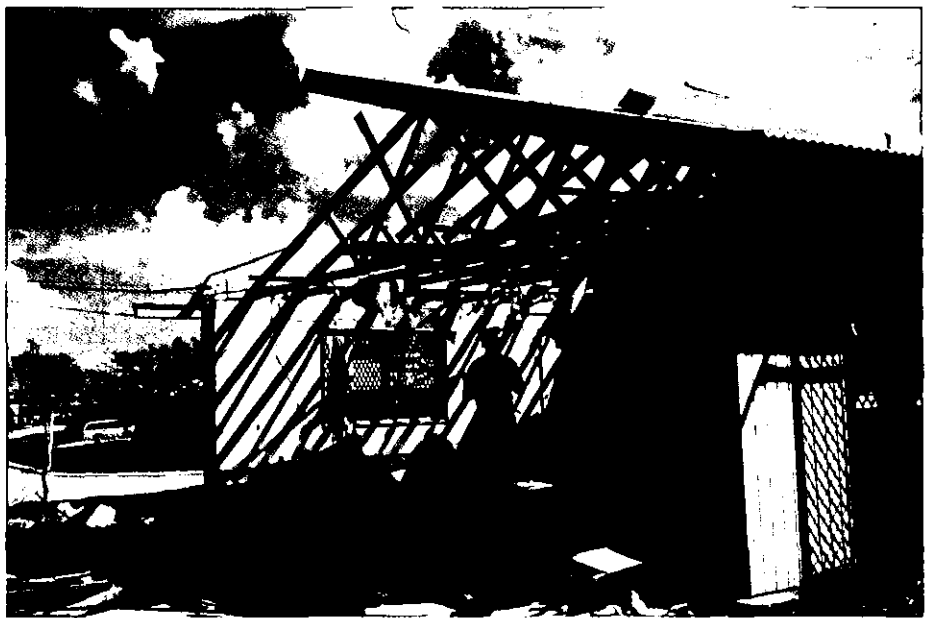
water entry and other damage. Doors on some of the US kit homes flew open when the striker plate tore out of the door jamb. This pressurised the interior of the houses and, in a number of instances, caused failure of the end wall. *Photo 5* shows such a failure.

Photo 5: Failure of the end wall due to interior pressurisation.

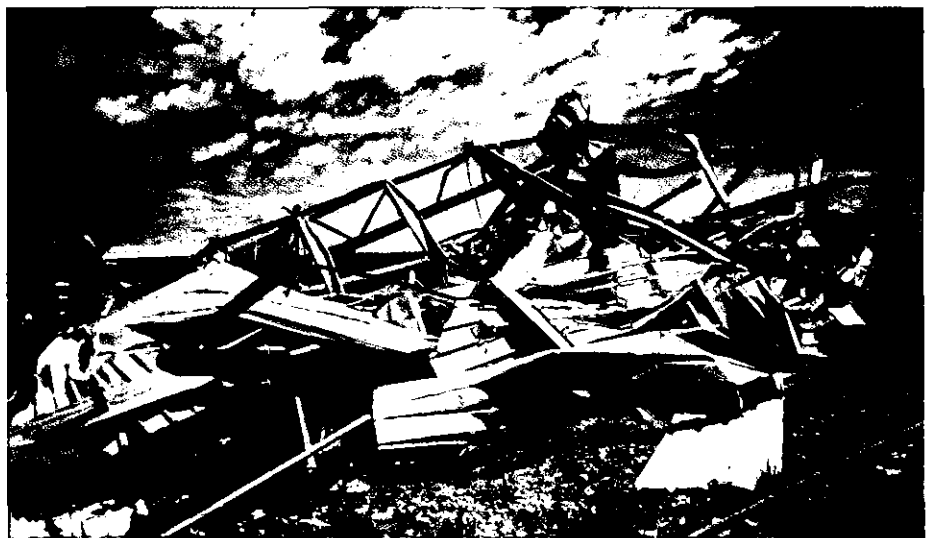
Most of the industrial buildings were fairly new. They usually had open webbed steel trusses on posts spaced two to three metres apart. Most resisted the wind forces, but sometimes lost some flashing or one or two sheets of cladding. There was one spectacular exception, where the columns pulled out of the ground, the building became flying debris, hit two others and finally wrapped around a light pole (*Photo 6*). A couple of older industrial buildings were stripped of all roofing. There were reports of this cladding from the industrial area flying to the adjacent residential area and causing missile damage to housing.

Photo 6: This entire building became flying debris, coming to rest wrapped around a light pole.
