Flying high with Field Operations

The ACMA's Field Operations Section has many responsibilities, including the important role of identifying and resolving interference to radiocommunications services. Recently, the team received notice of interference to the new 6.8 kilometre CLEM7 tunnel in Brisbane. An ACMA team was assembled to investigate the issue.

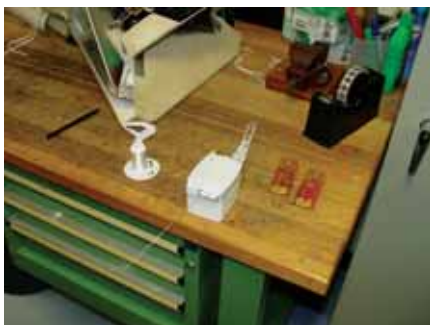
The cause of the interference to Brisbane's CLEM7 tunnel: a small transmitter located inside a meteorological balloon.

The Brisbane Meteorological Weather Station advised the Field Operations team that, while they have a spectrum frequency allocation of 400–403 MHz, the frequency of the transmitter on the weather balloon was drifting above this range and causing interference to CLEM7's land mobile radio systems.

Radiosonde's weather balloons are classified as meteorological aids. The Australian Radiofrequency Spectrum Plan allows their operation between 400.15 and 403 MHz. However, the radiosondes being used in Brisbane were causing interference because they were operating above 403 MHz in spectrum allocated for land mobile services.

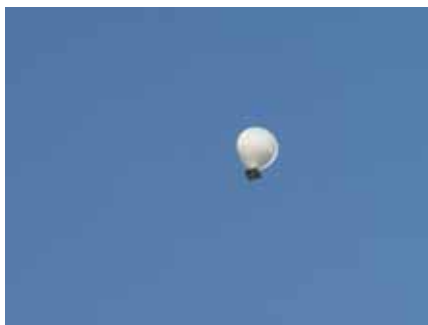
A meteorological balloon, similar to the one that caused the interference.

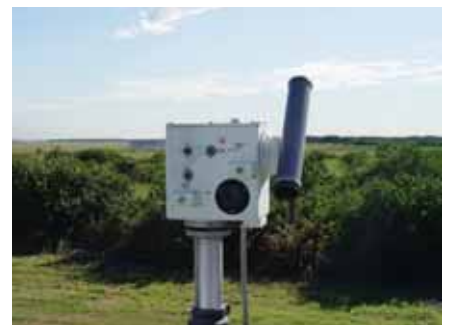
A tracking radar device used by the Bureau of Meteorology.
