Flood warning and awareness at Blandswood Peel Forest

South Canterbury, New Zealand

by Peter Kingsbury, Hazard Analyst,
Canterbury Regional Council,
Christchurch, New Zealand

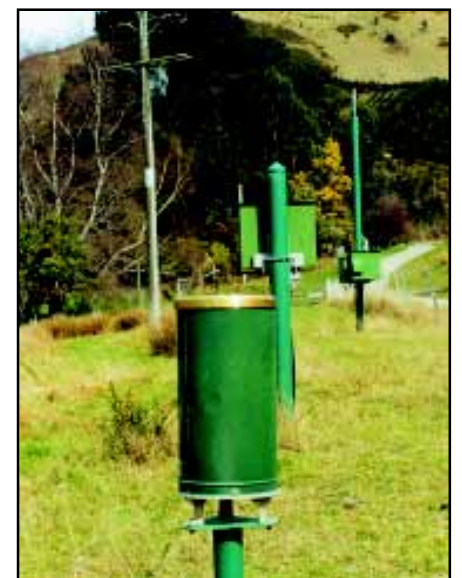
Figure 3: Telemetered rain gauge site at Blandswood

The flood warning system is based on antecedent rainfall, long-range weather forecasting and real-time weather surveillance. A telemetered rain gauge has been installed at Blandswood providing a daily rainfall record (*figure 3*).

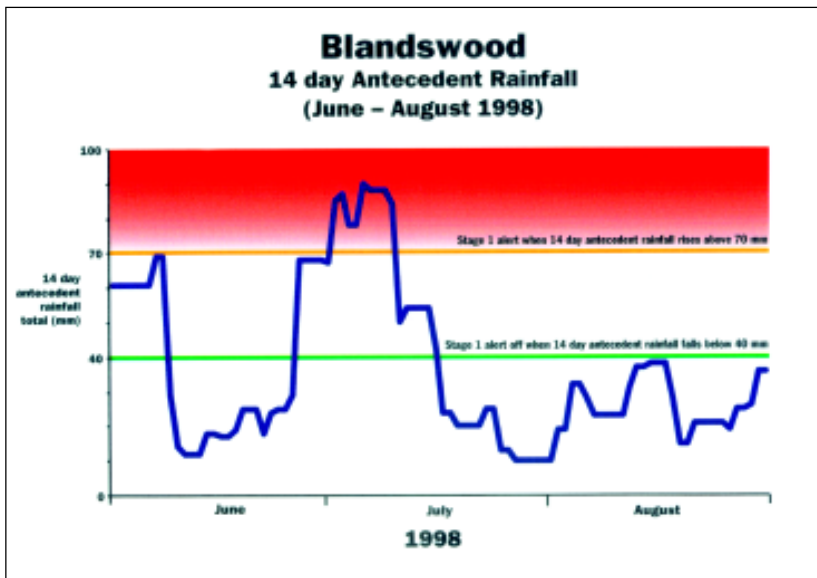
Figure 4: Antecedent rainfall record (June - August 1998)

A two stage warning system is in place. A Stage 1 alert occurs when a total of 70 mm of rain has fallen over the preceding 14 days (*figure 4*). When this critical level is reached the flood danger signs are changed from *LOW flood danger* to *HIGH flood danger* (*figure 5*). At this time people within the flood hazard zone may be advised directly of the flood alert state.

The local Civil Defence officer is advised and people evacuated from the flood hazard zone. Immediate evacuation is essential as devastating flood surges will take only minutes to reach Blandswood. The Stage 1 alert remains in place until the antecedent rainfall falls below 40 mm (*figure 4*).

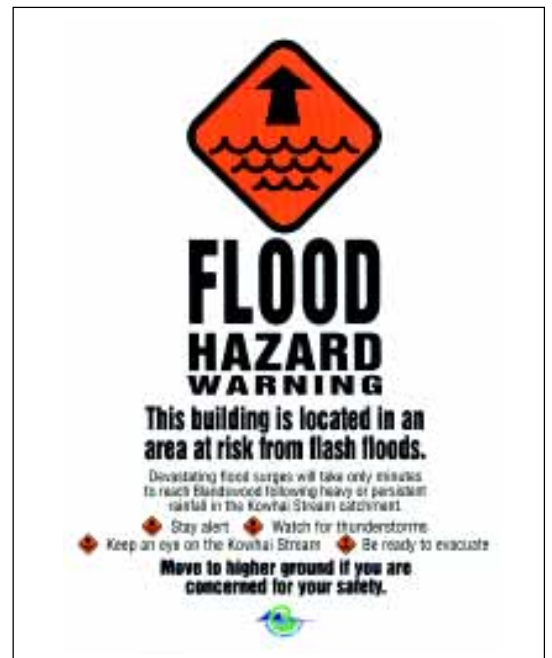
Figure 6: Flood warning notice displayed in homes in flood hazard zone

A flood hazard warning notice (*figure 6*) was sent to each property owner in the flood hazard zone. Property owners were encouraged to display the notice in a prominent place in their dwelling.

An 'international' symbol (indicating rising water) has been used deliberately on all signs and documents to link each source of information and provide a common theme (Figures 5, 6 & 7).

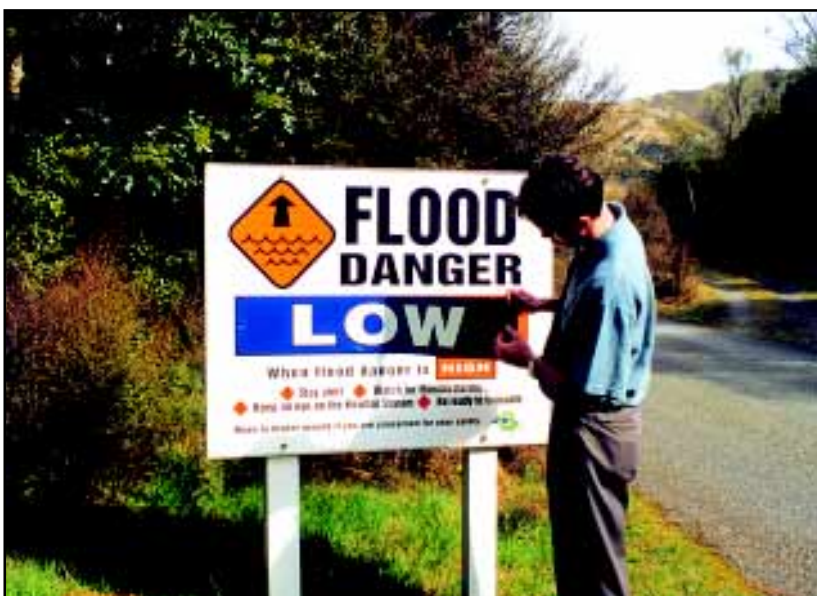
Figure 5: Changing the flood danger sign to 'HIGH' as the antecedent rainfall threshold (70 mm) is reached.

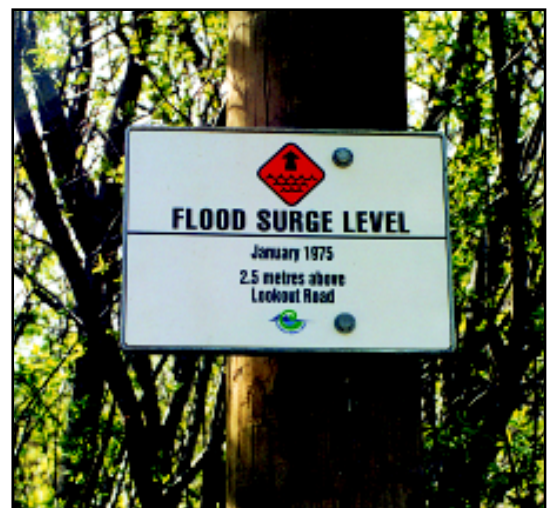
Figure 7: 1975 flood surge level

A sign indicating the 1975 flood level at Lookout Road is displayed in Blandswood (figure 7). Flood surges, estimated at up to 3.5 metres high, swept through Lower Blandswood in 1975.
